FINAL REPORT

TGP MLV 205-4 + 11.28 Failure – Root-Cause Analysis

November 16, 2011 Failure

Tennessee Gas Pipeline Company LLC

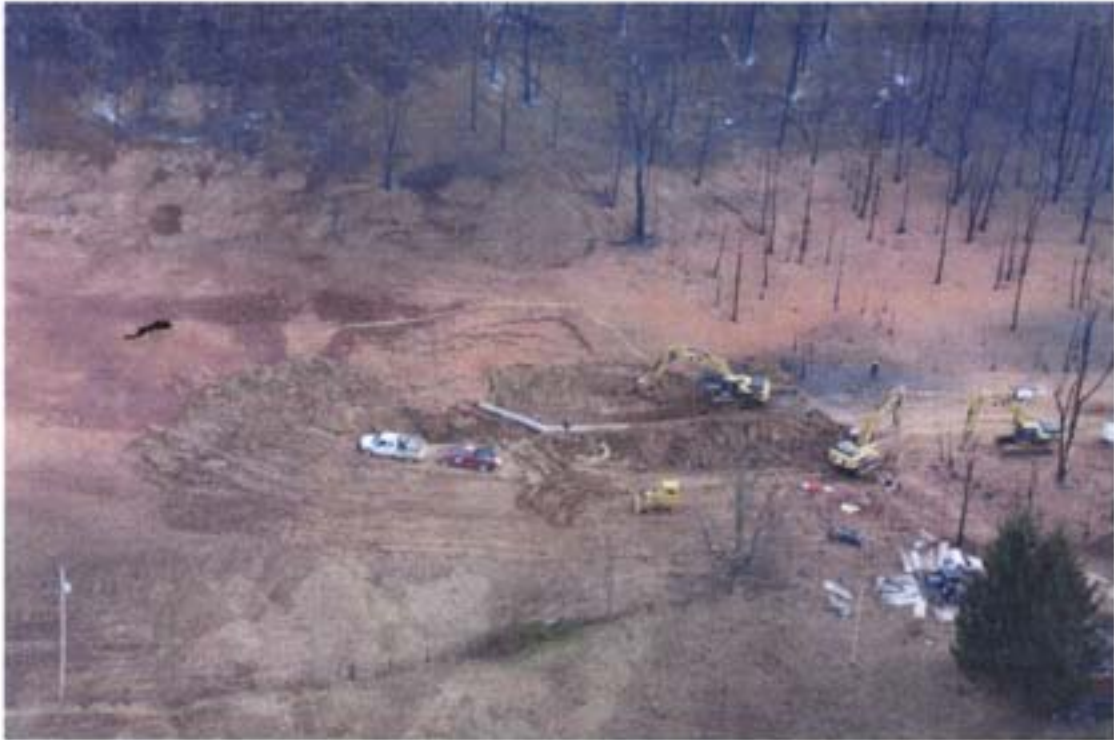
Figure 2. Aerial Photograph of Failure Site

[‡] Based upon geomorphic evidence, the failure site is located within a complex landslide, spans approximately 1,000 feet along the pipeline length, and usually appears to have displaced 5 to 6 feet downslope from an as-built position.

An aerial photograph of the failure site is provided in Figure 2. The direction of flow in this photograph is from right to left and shows a section of pipe extending from the crater produced by the failure. A photograph of the soil located at an elevation higher than the crater produced by the failure is provided in Figure 3 and shows the fissures that developed near the crater. These fissures were not evident immediately after the failure but developed several days after the failure. The potential for soil movement is evident from this photograph taken a few days after the failure.

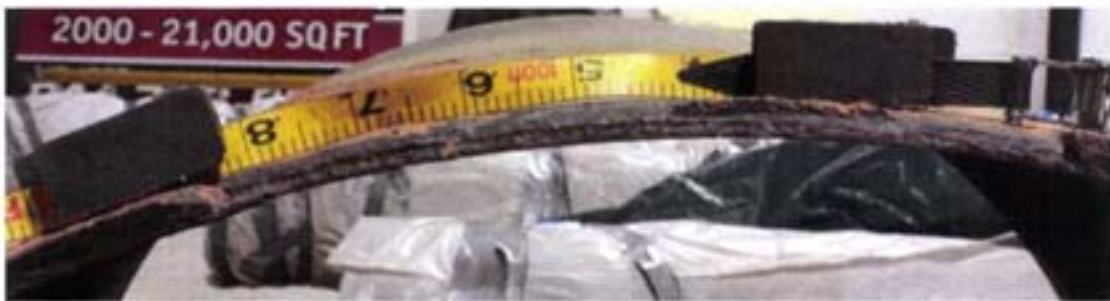
Figure 4. Photograph of the fracture surface from Failed Girth Weld Section (U/S) from approximately 0 to 1 foot clockwise (looking D/S) of TDC.

The contributing factors for this failure are best described by the conditions relative to the girth weld procedures and practices at the time of construction. These conditions resulted in the formation of a hydrogen-assisted cold crack at the toe of the root pass in the heat affected zone of the weld that was produced at the time of construction. The crack in the girth weld, as well as the girth weld itself, acted as a stress concentrator and the displacement (strain) of the pipeline occurred through the on-going progression of the landslide. Even in the absence of a crack in the girth weld, the landslide likely could have resulted in a pipeline failure at a later time if the landslide remained undetected and unmitigated.

The DNV metallurgical report¹⁴ concluded that rupture initiated at a pre-existing crack in the field girth weld. A photograph of the girth weld fracture surface is provided in Figure 4. The morphology of the crack is typical of hydrogen-assisted cold cracking and initiated at the toe of the root pass on the pipe ID.

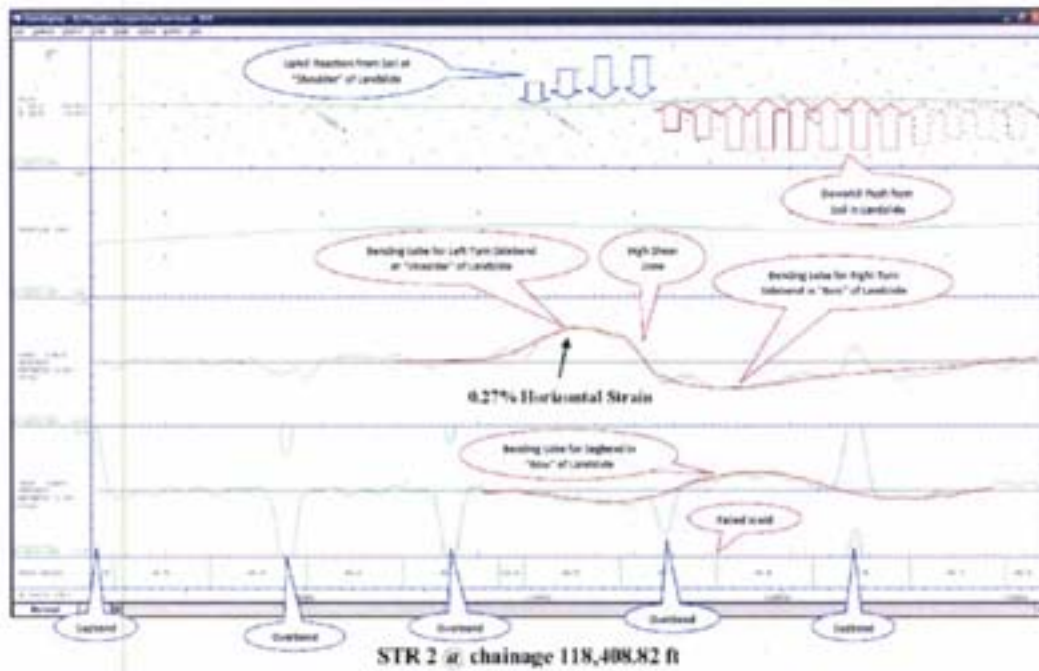
Figure 5. Preliminary Detailed Analysis of IMU Bending Strains in Proximity to MLV 205-4+11.28

An in-line inspection (ILI) was performed in June, 2011 using caliper, magnetic flux leakage (MFL), and inertial mapping unit (IMU) technologies. The original intent of the IMU was to obtain GPS centerline data for the pipeline. Post failure, TGP subjected the IMU data to a bending strain analysis,³ and identified 9 locations between MLV 204-4 and 209-4 where the bending strains exceed 0.2%.

The location of highest bending strain was reported to be 0.28% and covered a length of 159 feet. The failed girth weld was located within this 159-foot long section. Detailed analysis of this location is underway²¹ and a schematic of the IMU data at the failure location is provided in Figure 5. Additional work is currently underway with regard to reviewing the IMU bending strain data and integrating these IMU bending strain data with field measurements.

- Continued validation from 205-4 + 11.28 Failure. Capitalize on the findings from this analysis to further validate ILI IMU bending straining results. Establish procedures for the assessment of loads and strains acting on pipelines including acceptance limits.
